FLOOD OF MARCH 1968 ON THE SUDBURY, ASSABET, AND CONCORD RIVERS, MASSACHUSETTS

By  
R. G. Petersen, G. K. Wood, and R. A. Gadoury  
1970

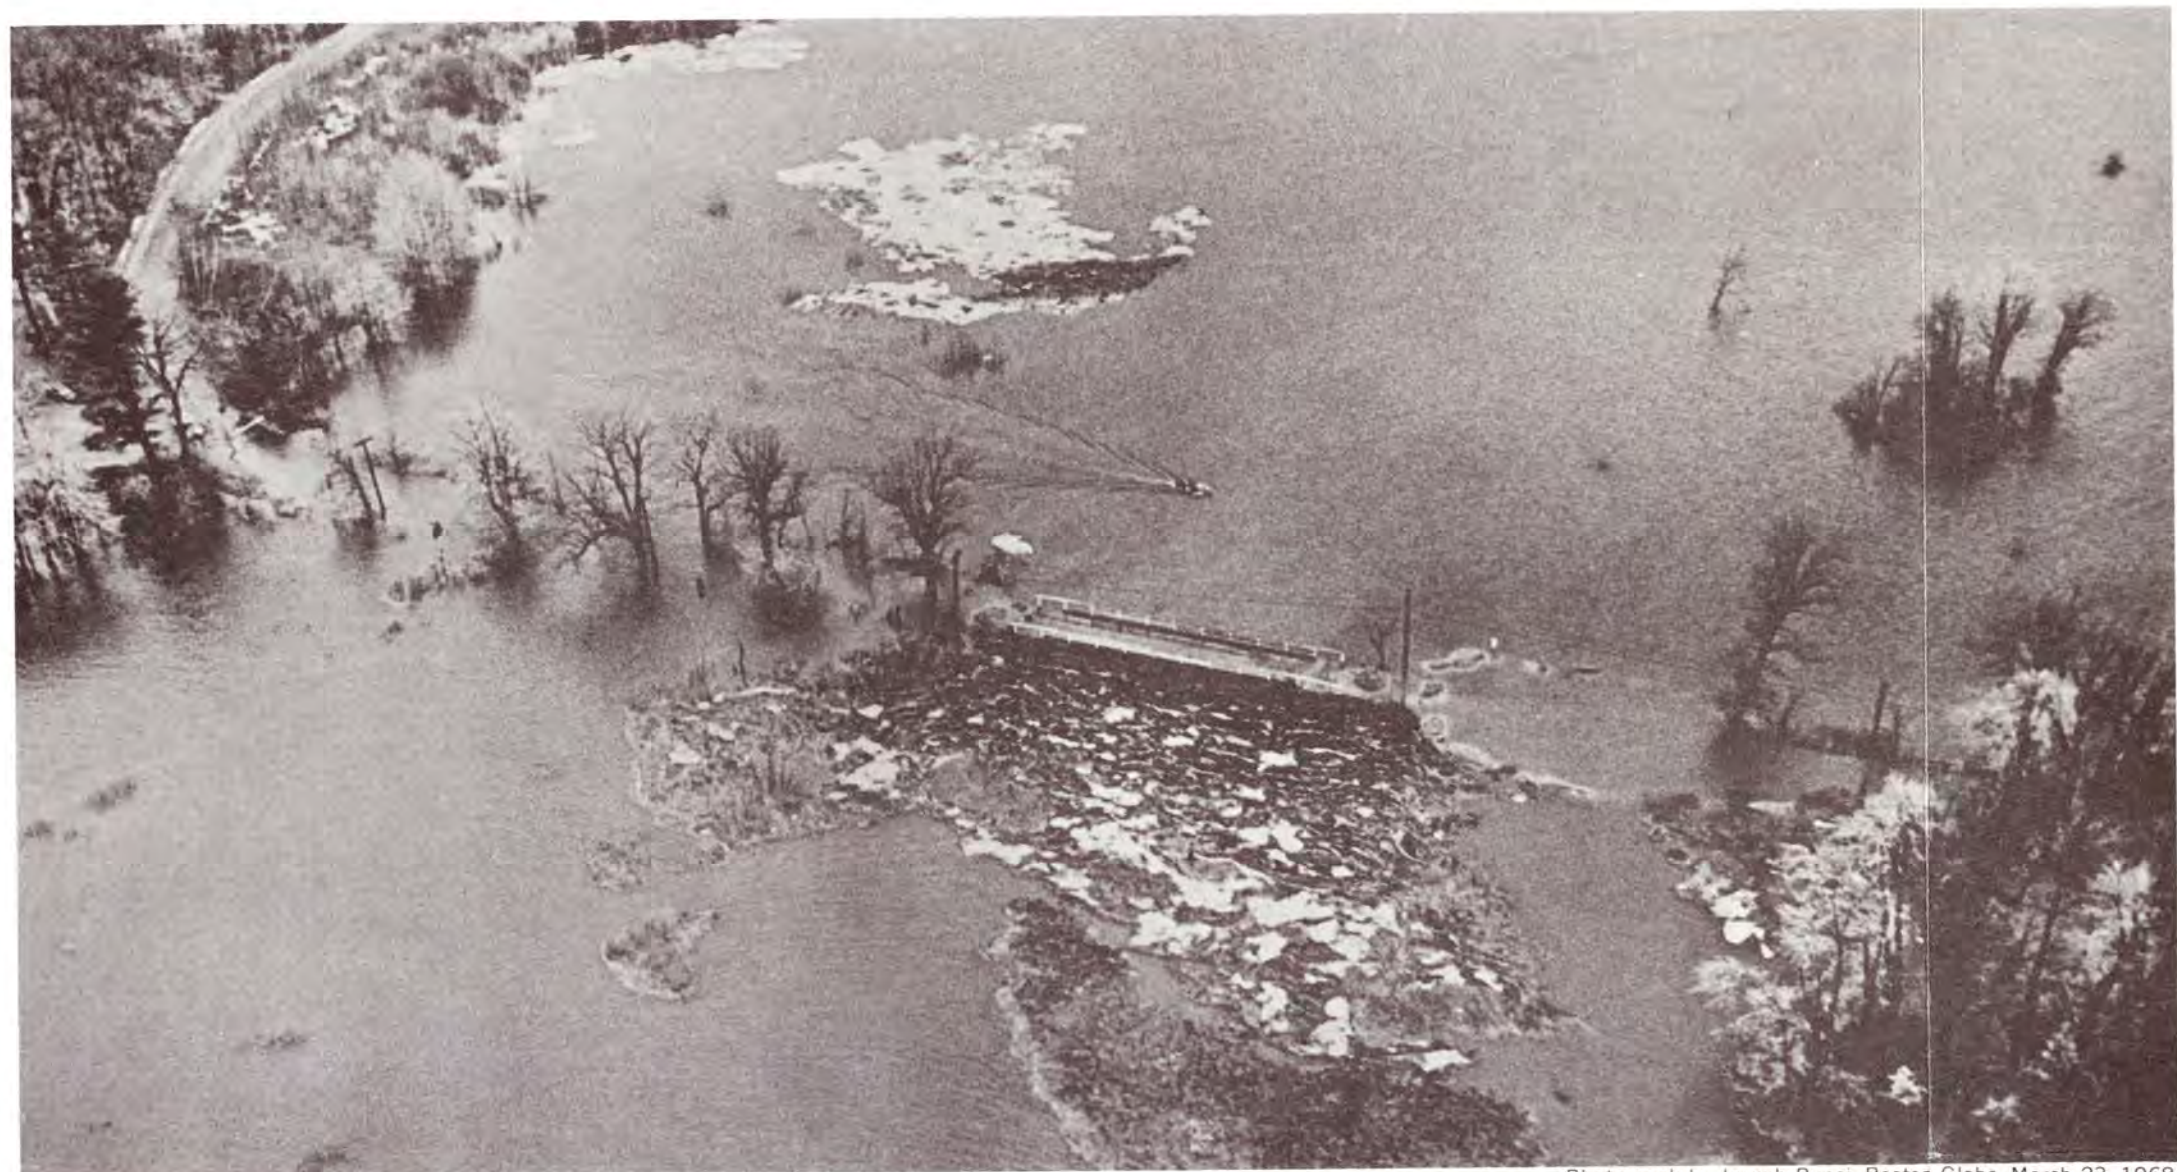
View of Sudbury River during flood showing debris piled against Sherman Bridge in Wayland. Photograph by Joseph Ranco, Boston Globe, March 23, 1968

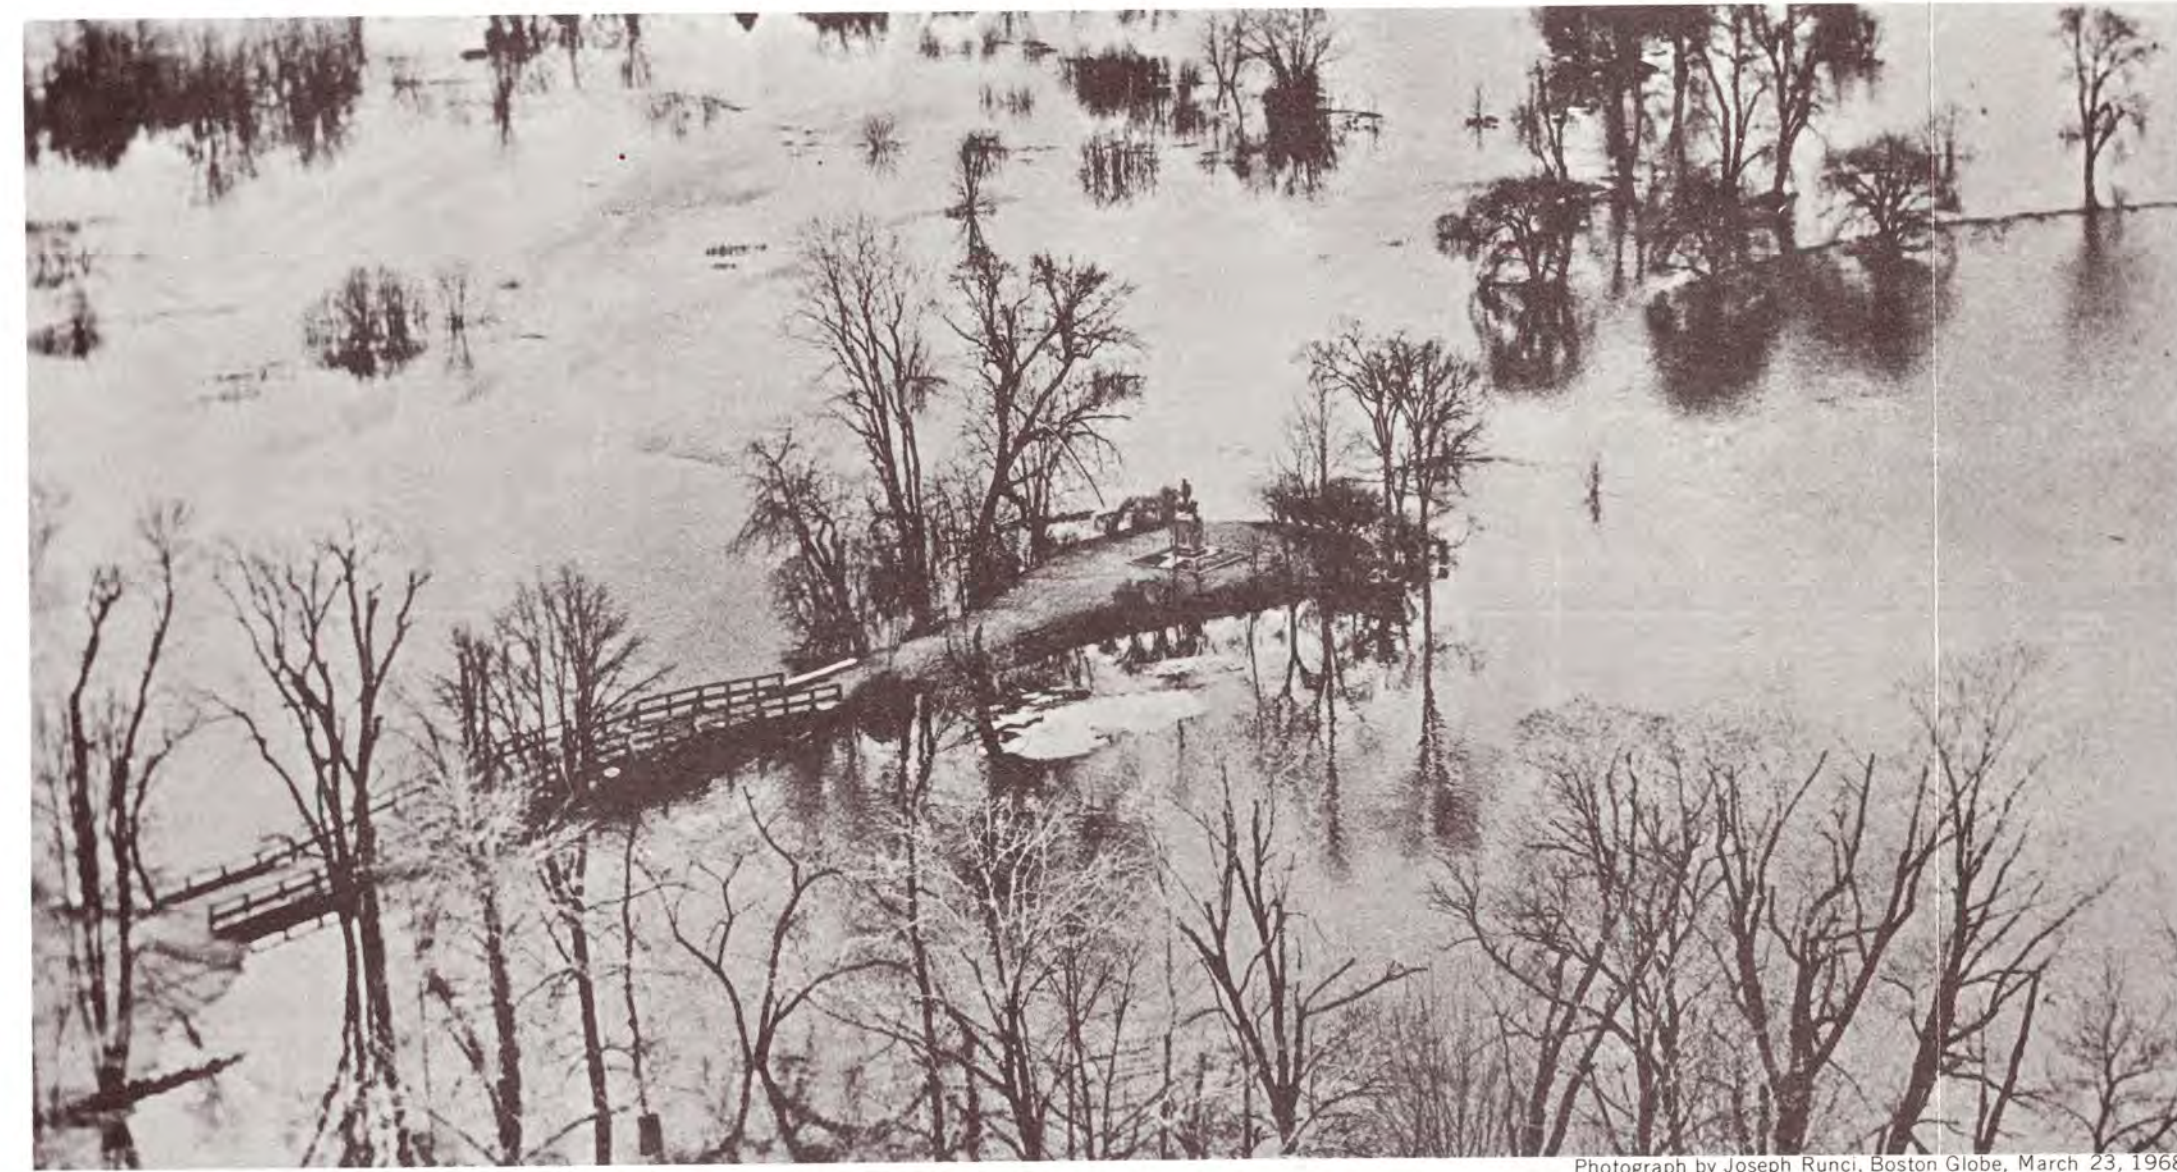
Floodwaters of Concord River at Minute Man Monument and Old North Bridge in Concord. The bridge is the one unscathed in Emerson's figure, 'By the road bridge that marked the flood.' Photograph by Joseph Ranco, Boston Globe, March 23, 1968

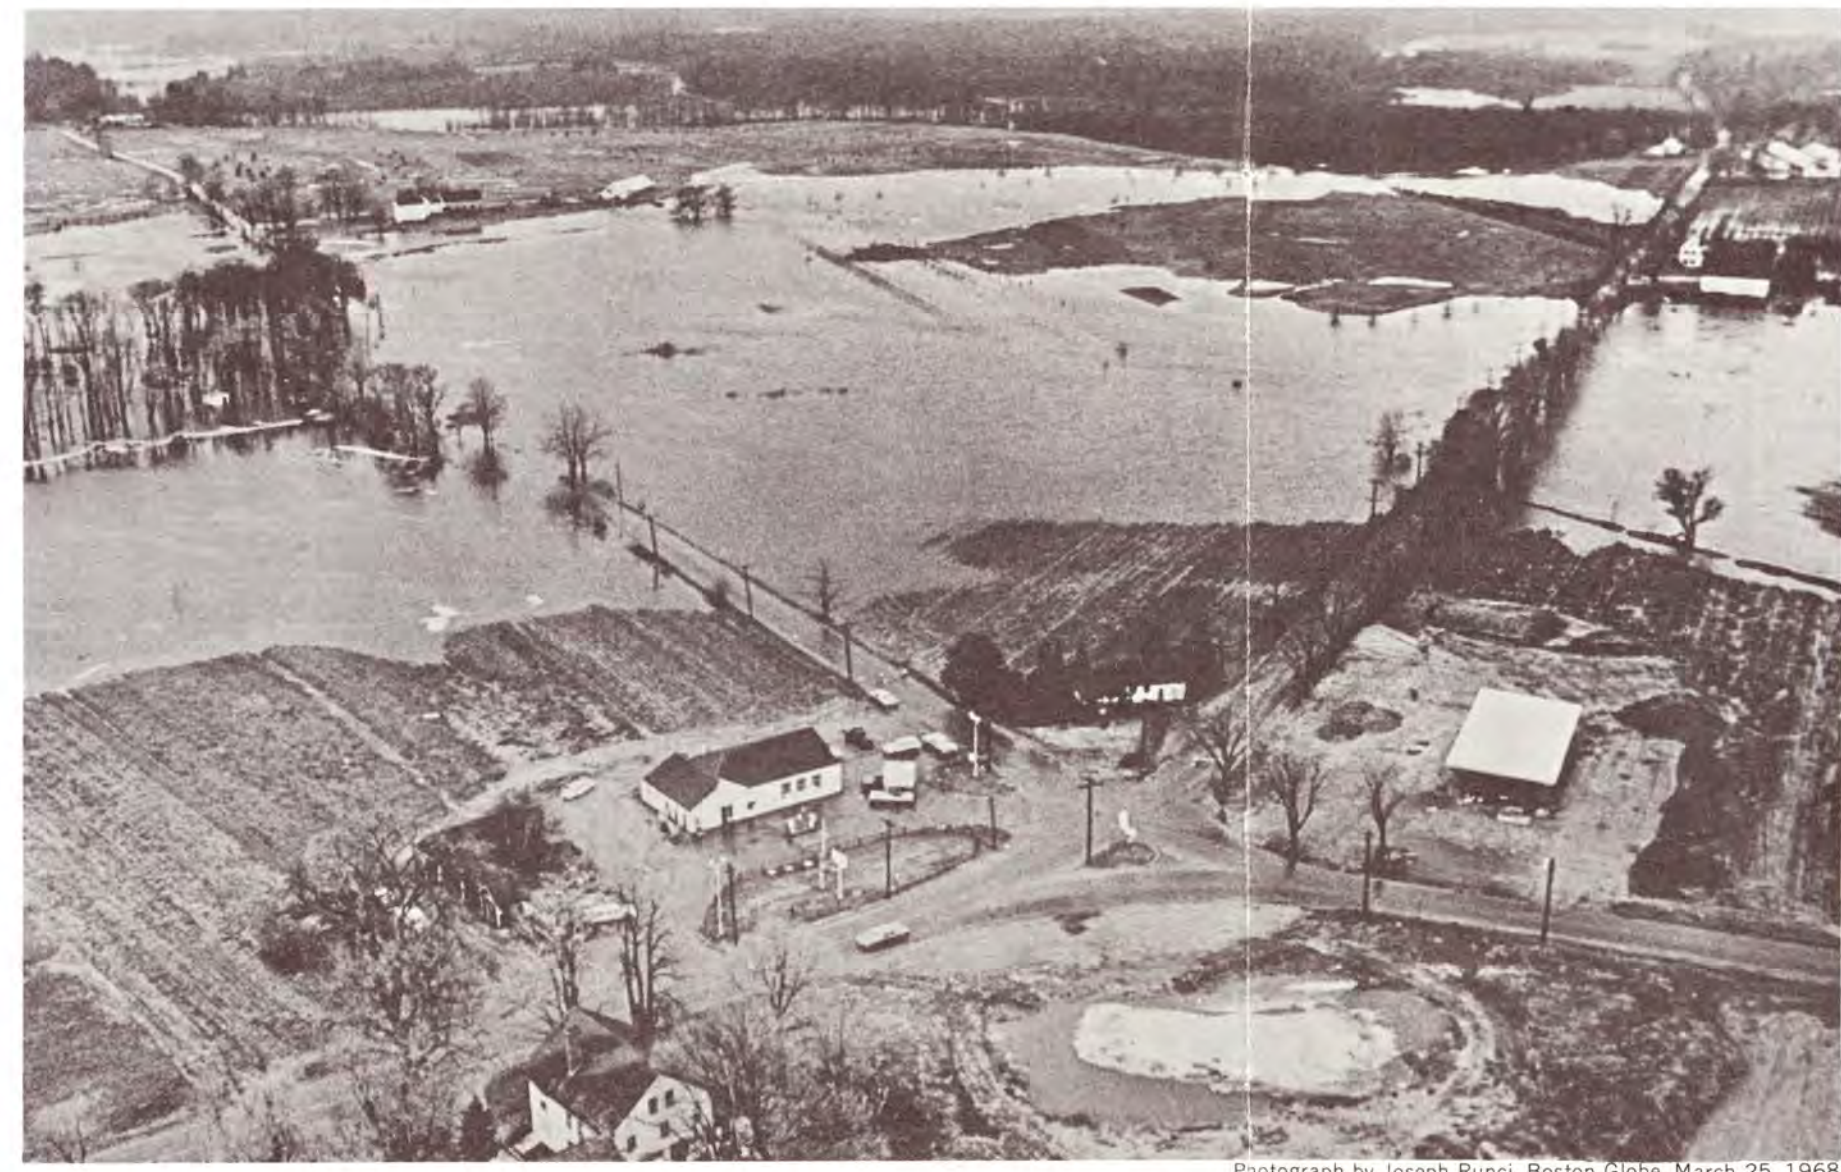
Intersection of Route 127 and Sudbury Road in Concord showing roads flooded by backwater from Sudbury River about 1/4 mile to the east. Photograph by Joseph Ranco, Boston Globe, March 25, 1968
