# **Elevation of the March–April 2010 Flood High Water in Selected River Reaches in Central and Eastern Massachusetts**

By Phillip J. Zarriello and Gardner C. Bent

Open-File Report 2010–1315

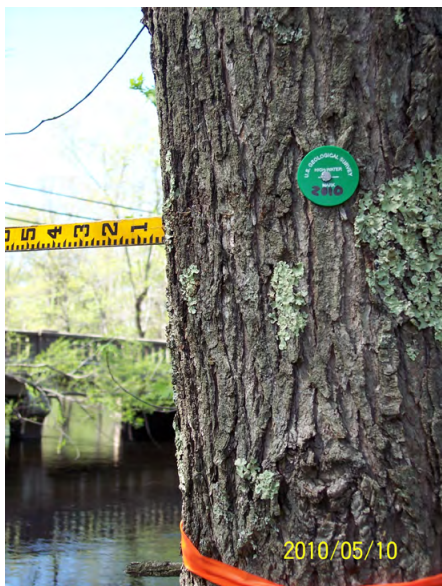
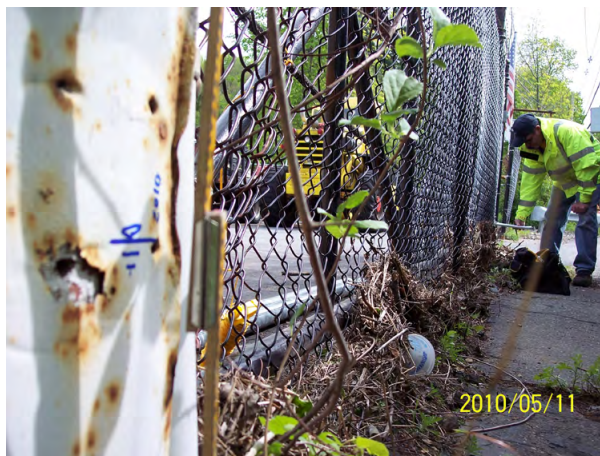
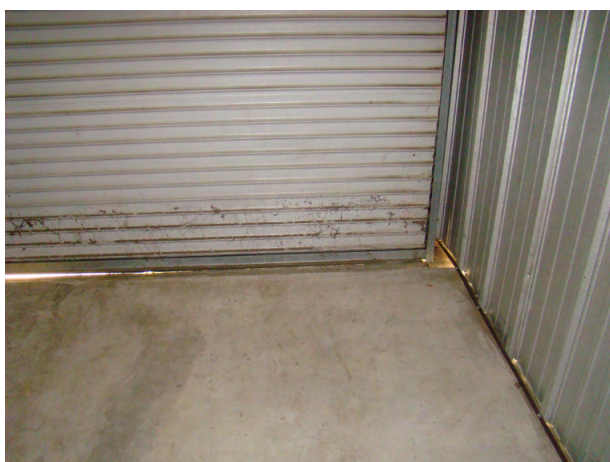
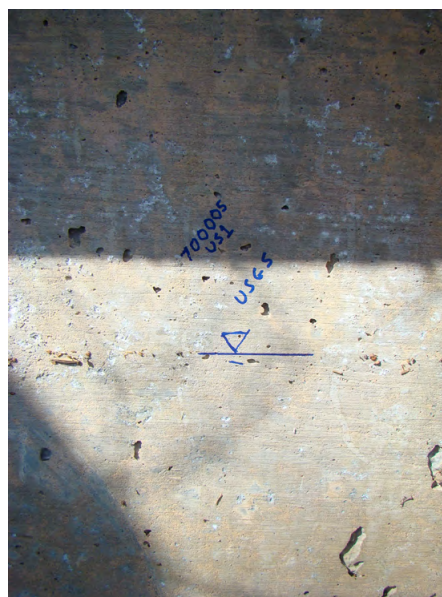
Ipswich River (IpsSR)

Indian Head River (IHRKS)

Nashua River (A80000)

Assabet River (A700005)

**Figure 5.** Examples of high-water mark debris lines on trees and structures found following the March–April 2010 floods in central and eastern Massachusetts. Value in parentheses refers to the Site\_ID in Appendix I, table 1-1.

stranded at the highest water elevation. The best HWMs are small seeds or floating debris that adhere to smooth surfaces or lodge in tree bark that forms a distinct water line. Stain lines on buildings, fences, and other structures also provide excellent marks. HWMs are best identified immediately following the peak stage as time and weather (wind and rain) fade the evidence of the peak water line. Additionally, care was taken to identify HWMs farthest from the main channel as possible where velocities are generally small and pileup or drawdown's common in fast moving waters are best avoided. The general methods used to identify and document HWMs are described by Benson and Dalrymple (1967).
